Civil Engineering

April 2009 Vol 17 No 3

FOCUS ON GEOTECHNICAL ENGINEERING

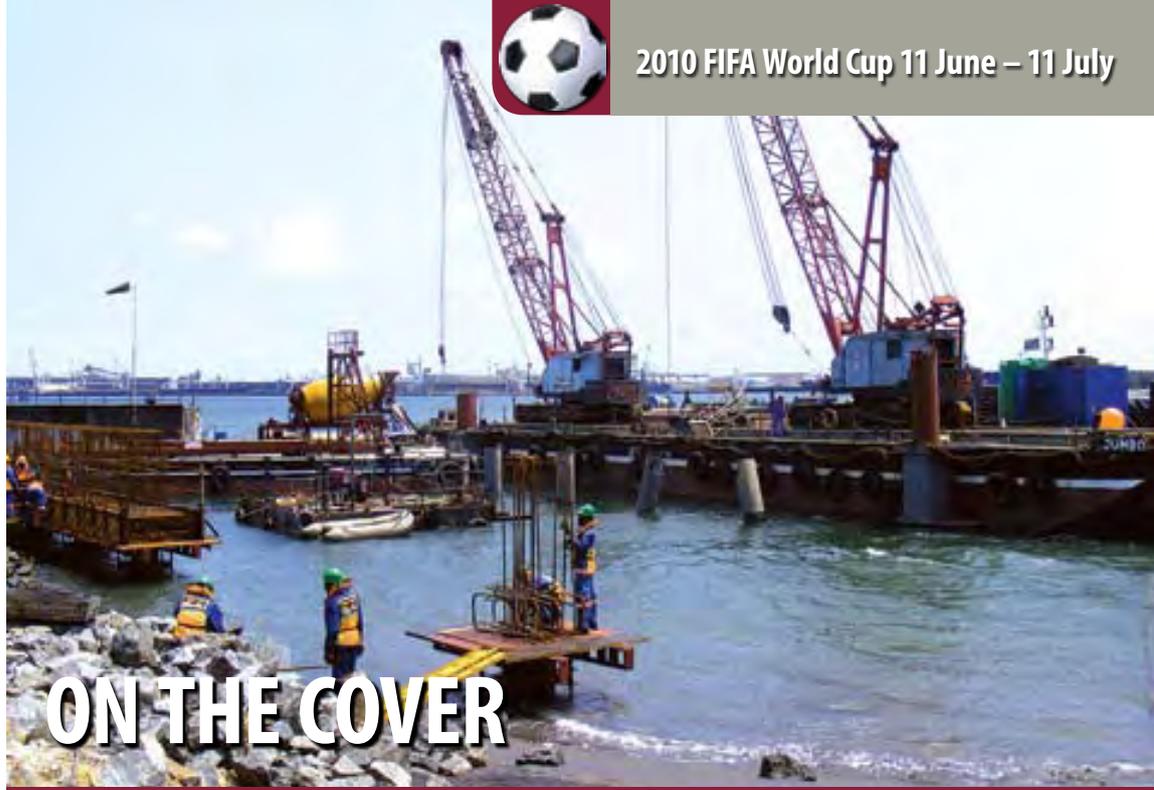
The installation of driven tube piles is always challenging, but doing so from a floating barge with spud legs in often choppy seas requires expertise par excellence. Franki Africa admirably meets the challenge in the Port of Richards Bay

Franki piles Berth 208 at Richards Bay 2

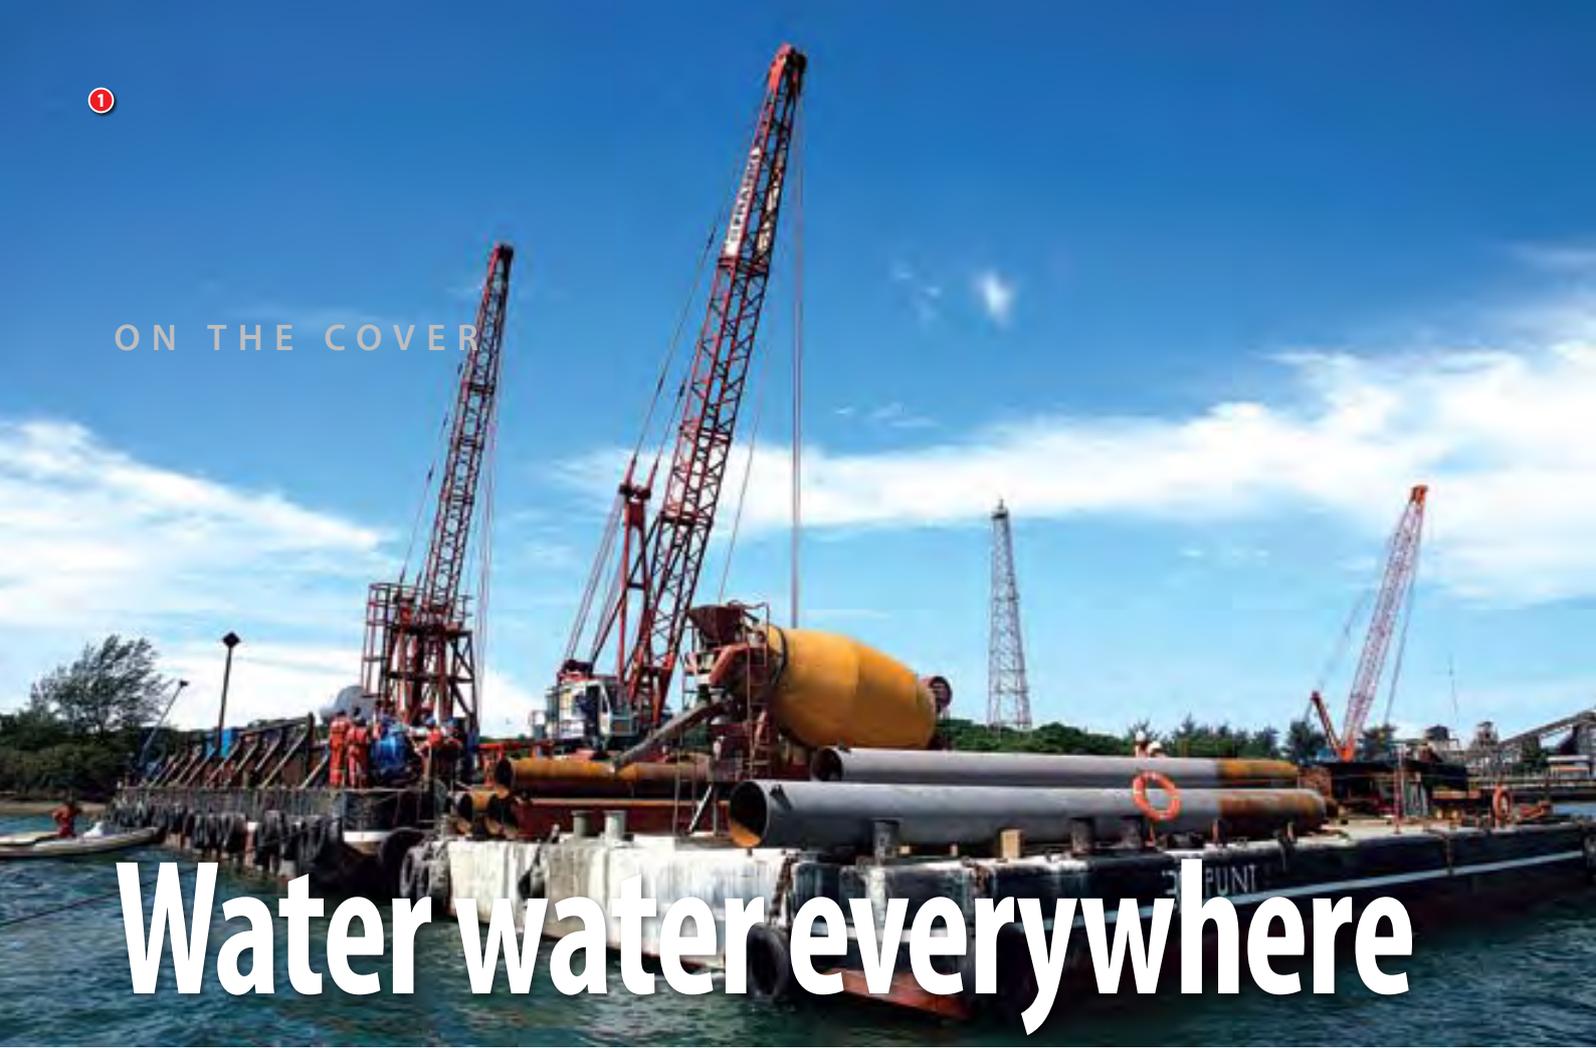
Water water everywhere

Franki has developed a reputation for being able to handle demanding piling jobs, and few jobs could be more demanding than the R213 million

Byrne explains that driven tube piles are widely used in a marine environment since they have the advantage of easily providing a supporting member to structures located in the sea. Careful assessment of the corrosive environment must be undertaken to ensure that the durability requirements are met. He adds that cathodic protection or durable coatings are generally essential to ensure long-time durability. "A wide range of pile diameters, from 300 mm for minor structures to 1 500 mm for heavy marine applications, can be installed where poor soil conditions underlie the site."

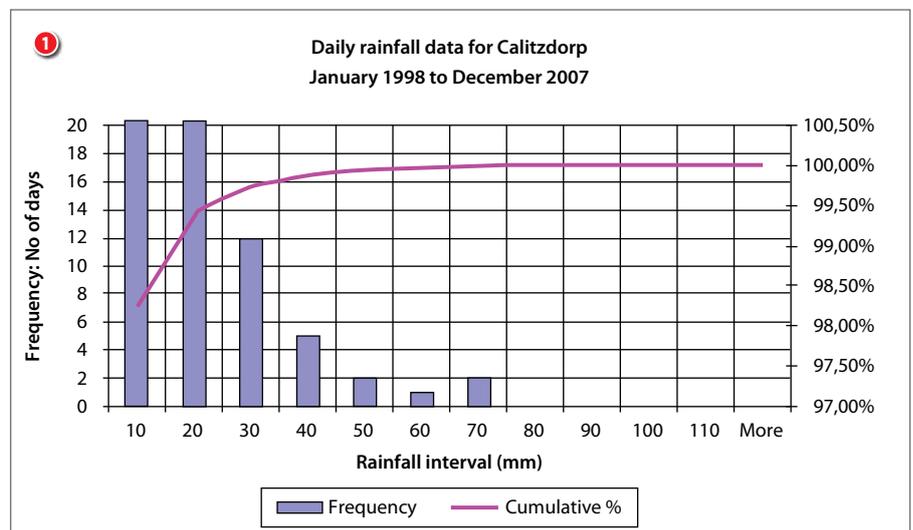
① Daily rainfall data for Calitzdorp

The main trigger mechanism associated with nearly all slope failures is the introduction of water to the slope. During November 2007, Huis River Pass received more than 100 mm of rainfall in one day. It is interesting to note that in the previous ten years of rainfall history in the area, a maximum one-day rainfall figure greater than 50 mm was recorded on only three occasions.

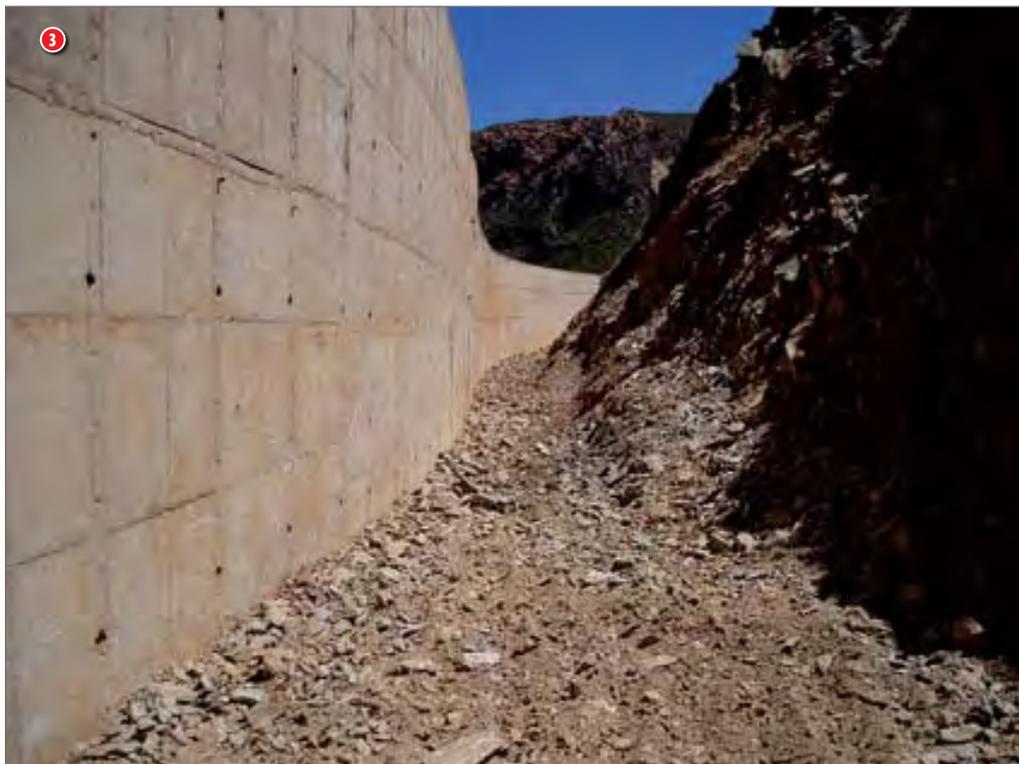
- 4 Retaining wall after rainfall events (January 2008). Photo taken from the top of the 6-m-high retaining wall
- 5 View site rockfalls (December 2007)
- 6 Restraining mesh system showing tensioned diagonal cables

The slope failure at the view site consisted of a mass movement of oversaturated crest and upper slope material, which had been 'lubricated' at the soil/rock interface. Significant areas of highly fractured and randomly orientated rock were destabilised by the rainfall events and there were several close calls for construction vehicles (see Photo 5).

- Installation of permanent rock bolts 2,0 to 5,0 m in length, set approximately 10,0 m back from the crest of the 65-m-high slope. The view site is approximately 250 m long. The rock bolting arrangements were installed in two distinct arrangements:
 - The 3,0 m rock bolts were used predominantly as summitry and basal anchorage for the drapery mesh system, but also served to restrict the

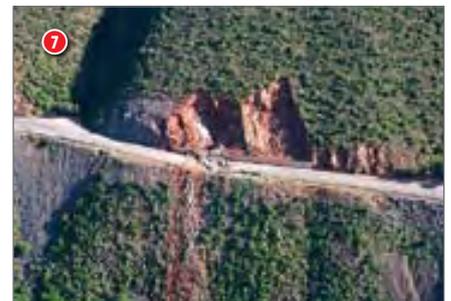
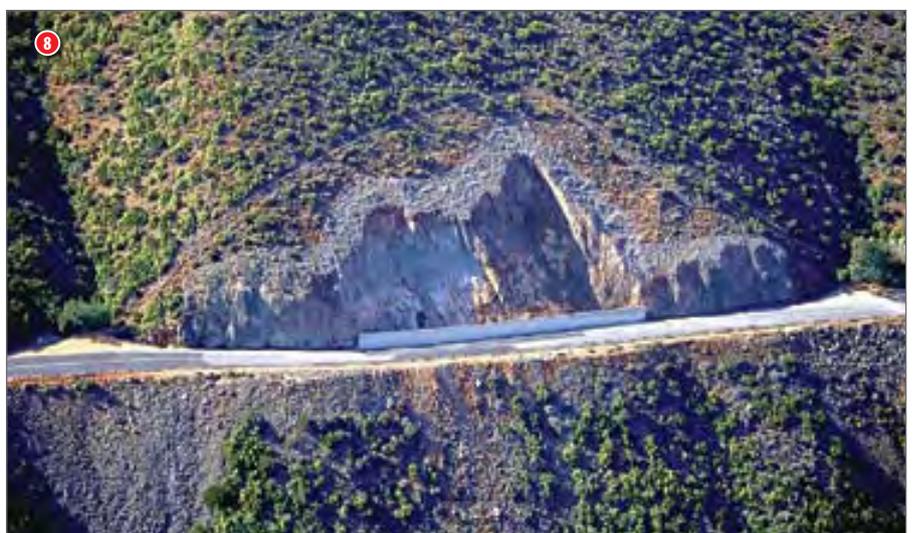
7 Retaining wall 4 rockfalls (December 2007)

failed rock mass was underlain by highly fractured rock with fracture or bedding planes infilled with a clayey silt. When the fracture or bedding planes were sufficiently lubricated, the rock mass slid (see Photo 7).

The original contract allowed for remedial work behind this retaining wall in terms of rock debris removal and reconstruction of the damaged wall only. The nature of the rock movement demonstrated that a further significant rock mass behind the wall was potentially unstable and needed immediate stabilisation if further damage to the wall was to be avoided. The remedial stabilisation work comprised the following:

- Stabilisation of the affected crest areas was undertaken using the same arrangement of permanent rock bolts and restraining mesh as was employed at the view site. Approximately 96 rock bolts and 4 100 m² of drapery mesh were installed at the crest of this retaining wall.
- The highly fractured rock layer also provided a water pathway which had the potential to destabilise further rock masses on the slope. In order to stabilise this precarious rock area, drapery mesh and steel-fibre-reinforced shotcrete was sprayed over the mesh. The steel fibres were incorporated into the shotcrete to improve its flexural strength.

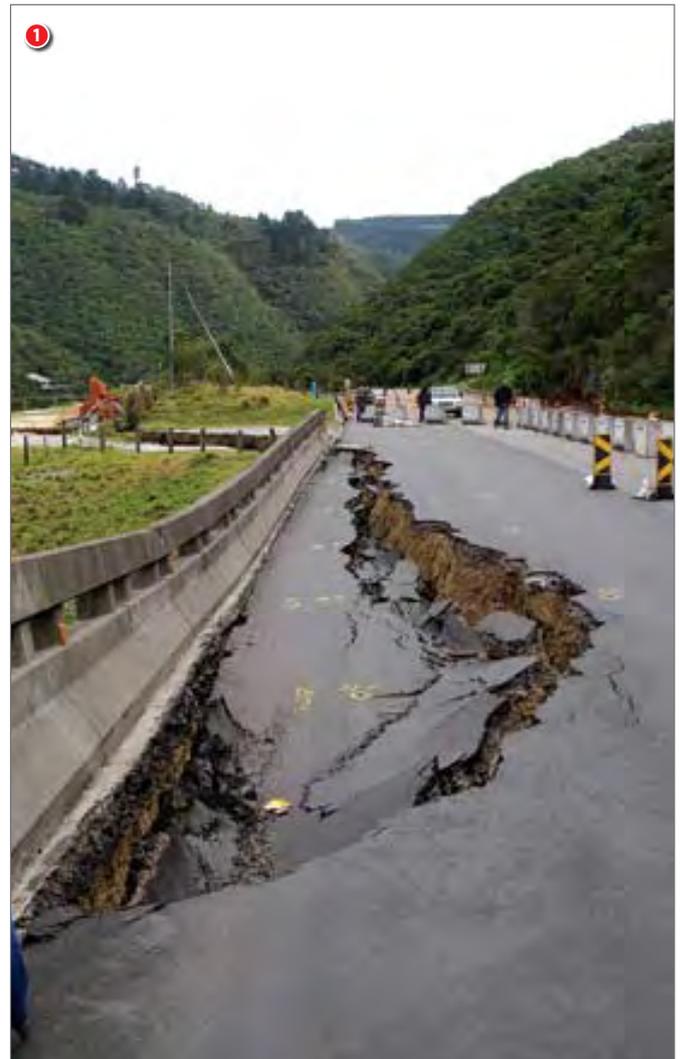
① Failure of roadway

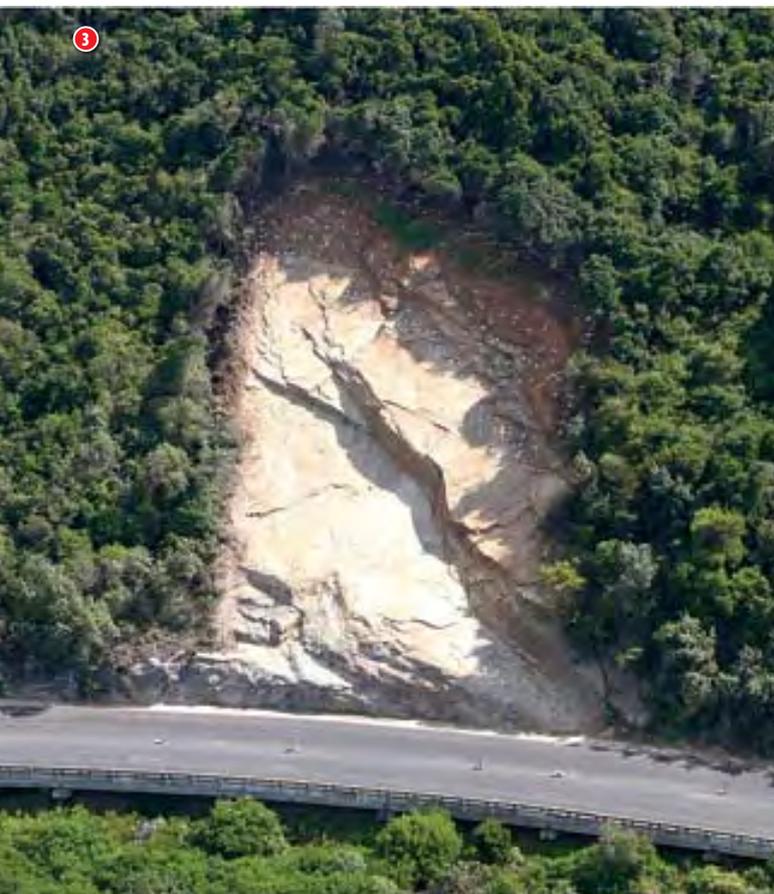
② Planar failure before remedial works

After all debris had been cleared off the second failure slope, pattern rock bolting was installed to pin the weathered rock mass together. Mesh-reinforced shotcrete was applied to the rock face to prevent ravelling and long-term weathering of the rock mass. Drainage holes, 6 m long, were drilled into the rock mass to intercept groundwater and so minimise the possibility of excessive groundwater pressures occurring within the rock mass.

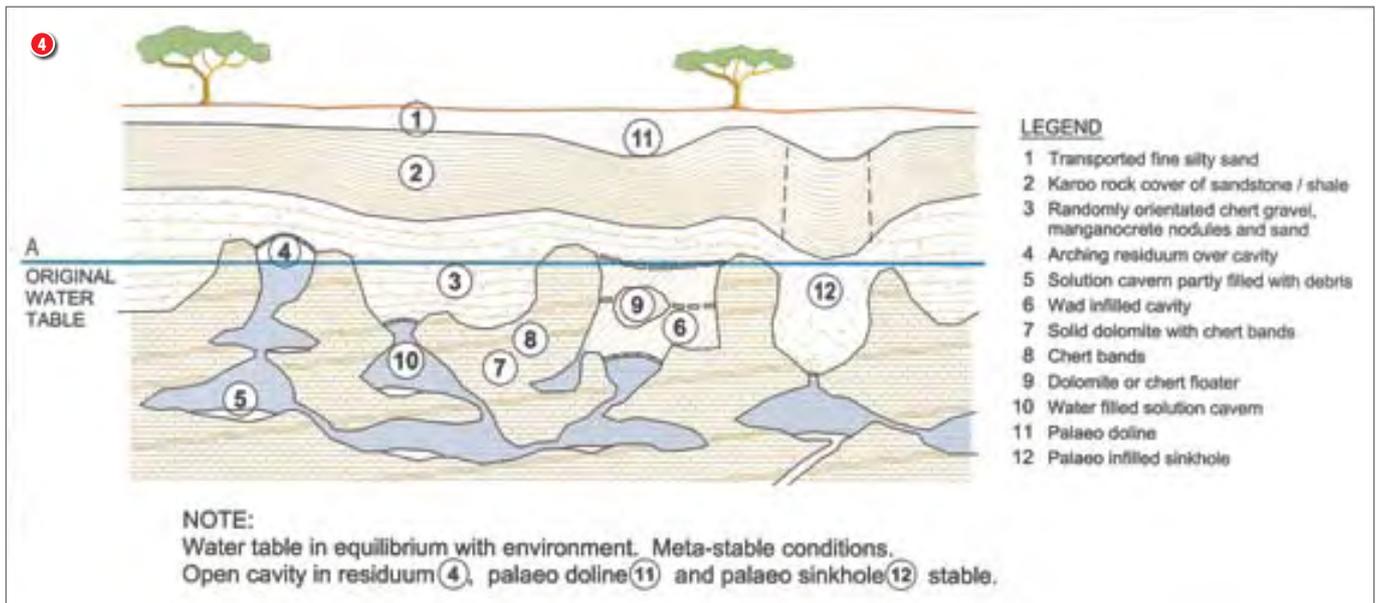
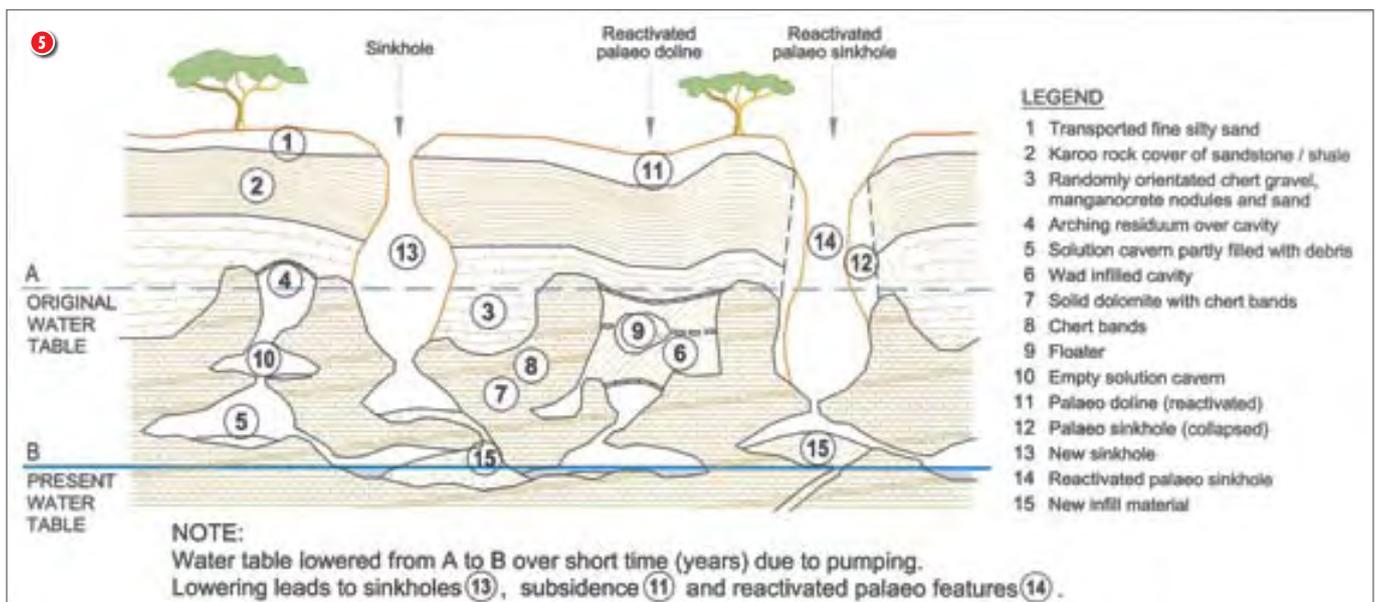
4 Typical soil profile over dolomite before dewatering

It is appropriate to give a brief description of the mechanisms of sinkhole and doline formation. A sinkhole is a feature that occurs suddenly and manifests itself as a hole in the ground. A doline is an enclosed depression or subsidence that usually occurs gradually. Both can occur in a dewatering or non-dewatering situation.

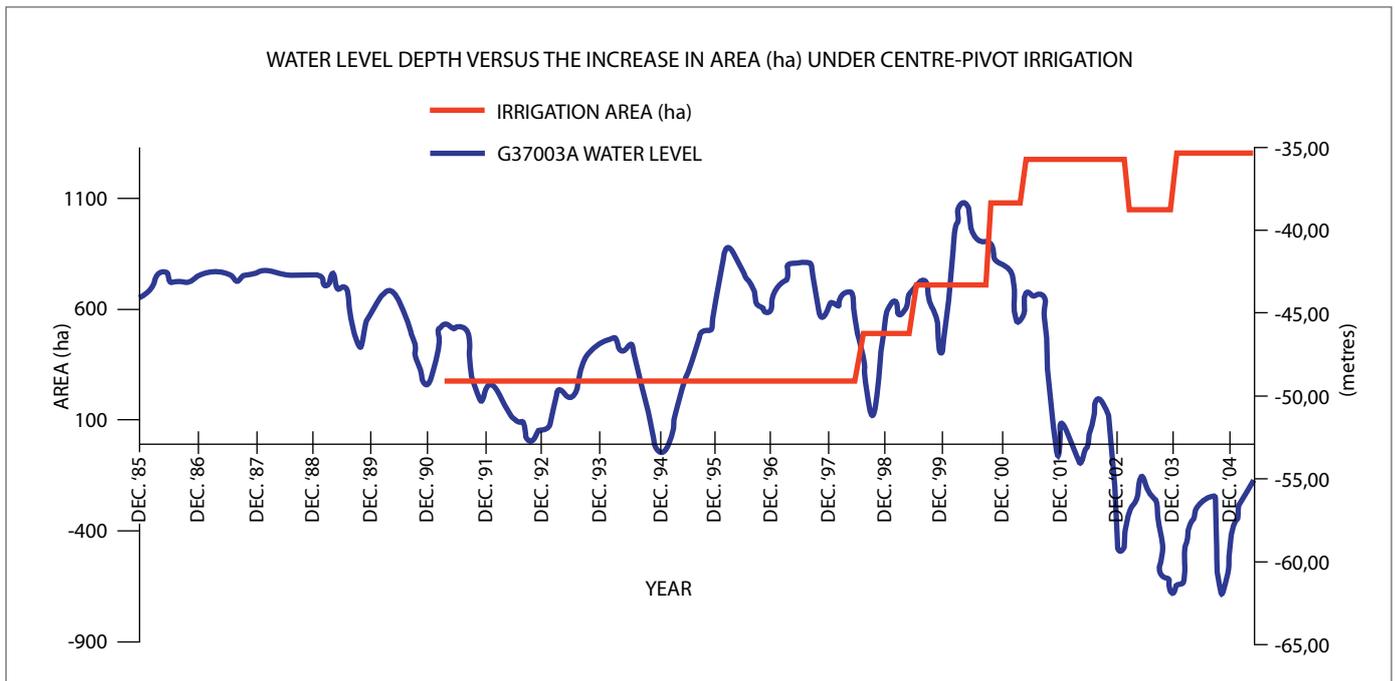
the area under centre-pivot irrigation by Nel (2004). The plot of borehole G37 003A is shown in Figure 9. The water level in this borehole was found to be fairly constant before 1989, showing only small seasonal variations. As pumping increased, the seasonal changes became larger, and between 1999 and 2004 a 20 m lowering of the water table was encountered at this borehole, corresponding to a large increase in centre-pivot irrigation over this period.

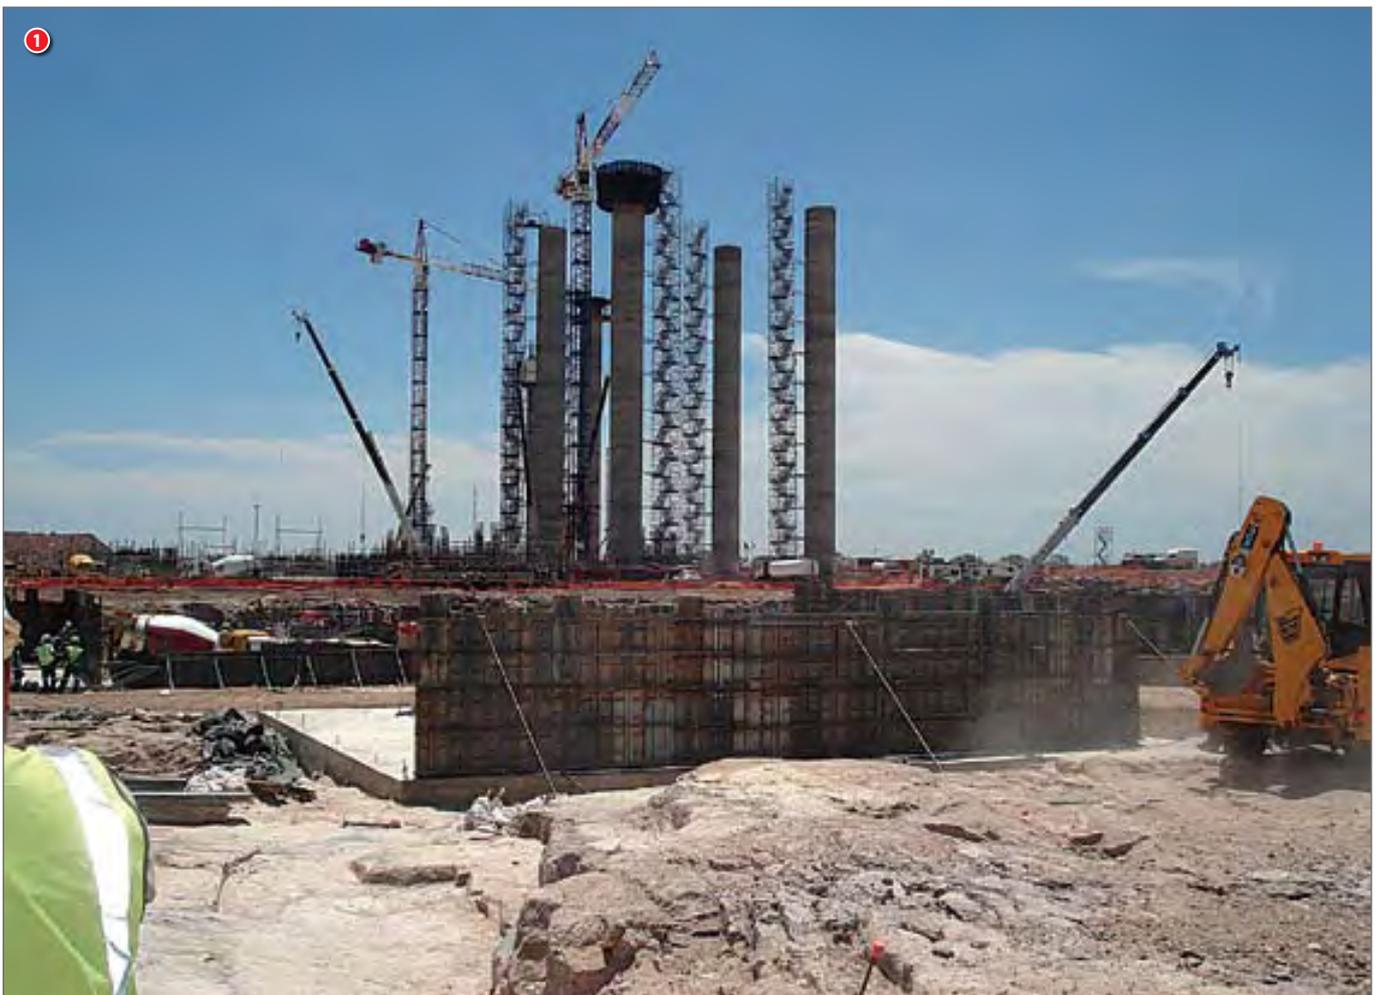
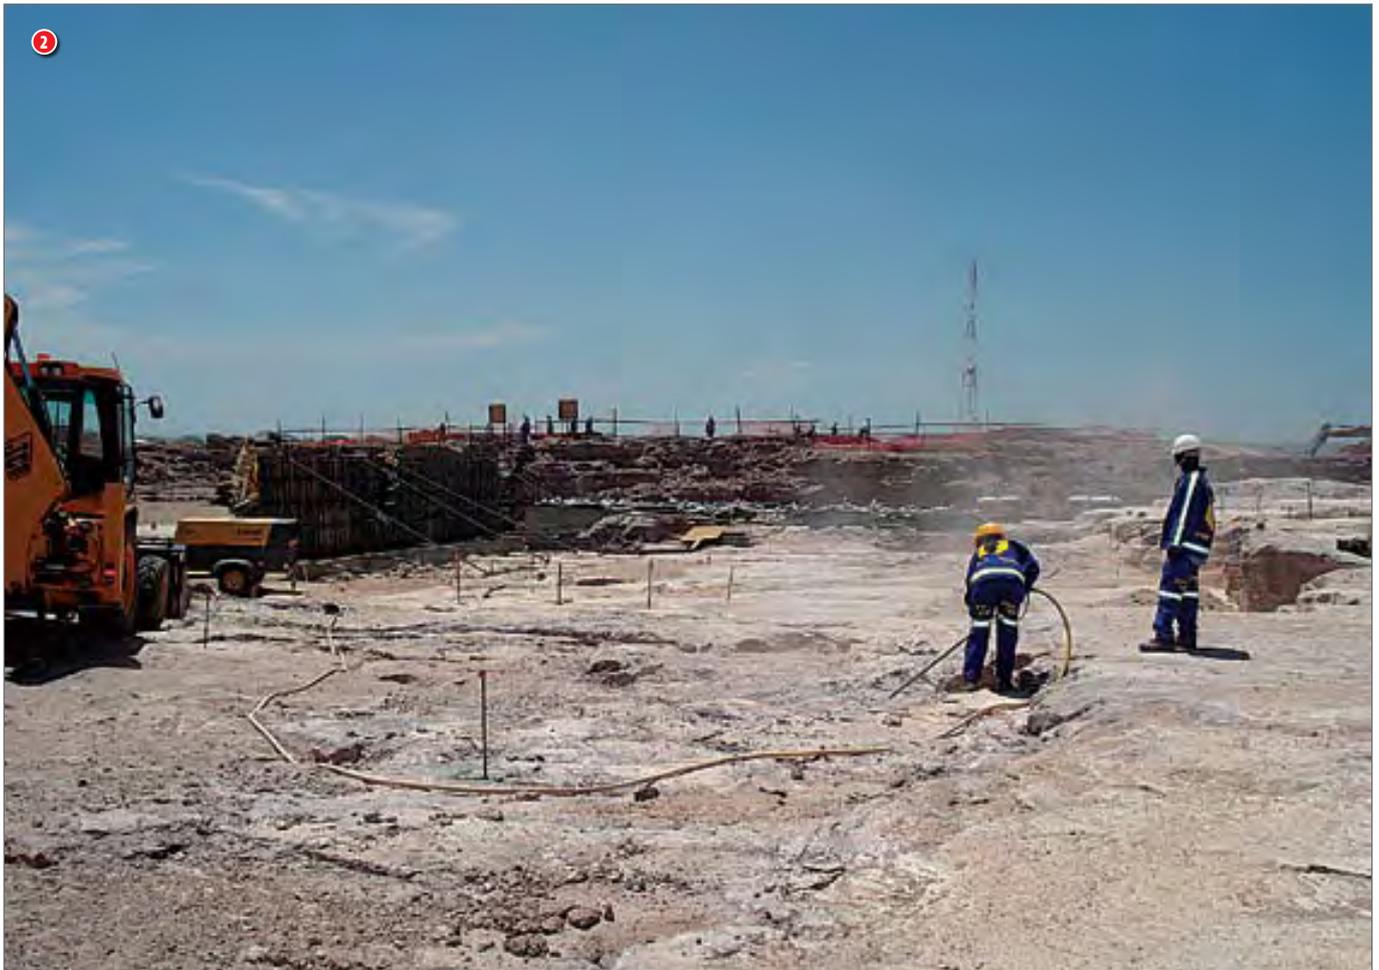
- ① Foundation cleaning in foreground and construction of Unit 6 air-cooled condenser columns in the background
- ② Final cleaning of foundation footprint using compressed air

In order to ensure the adequacy of the foundation rock, each foundation is subjected to a geotechnical mapping procedure to

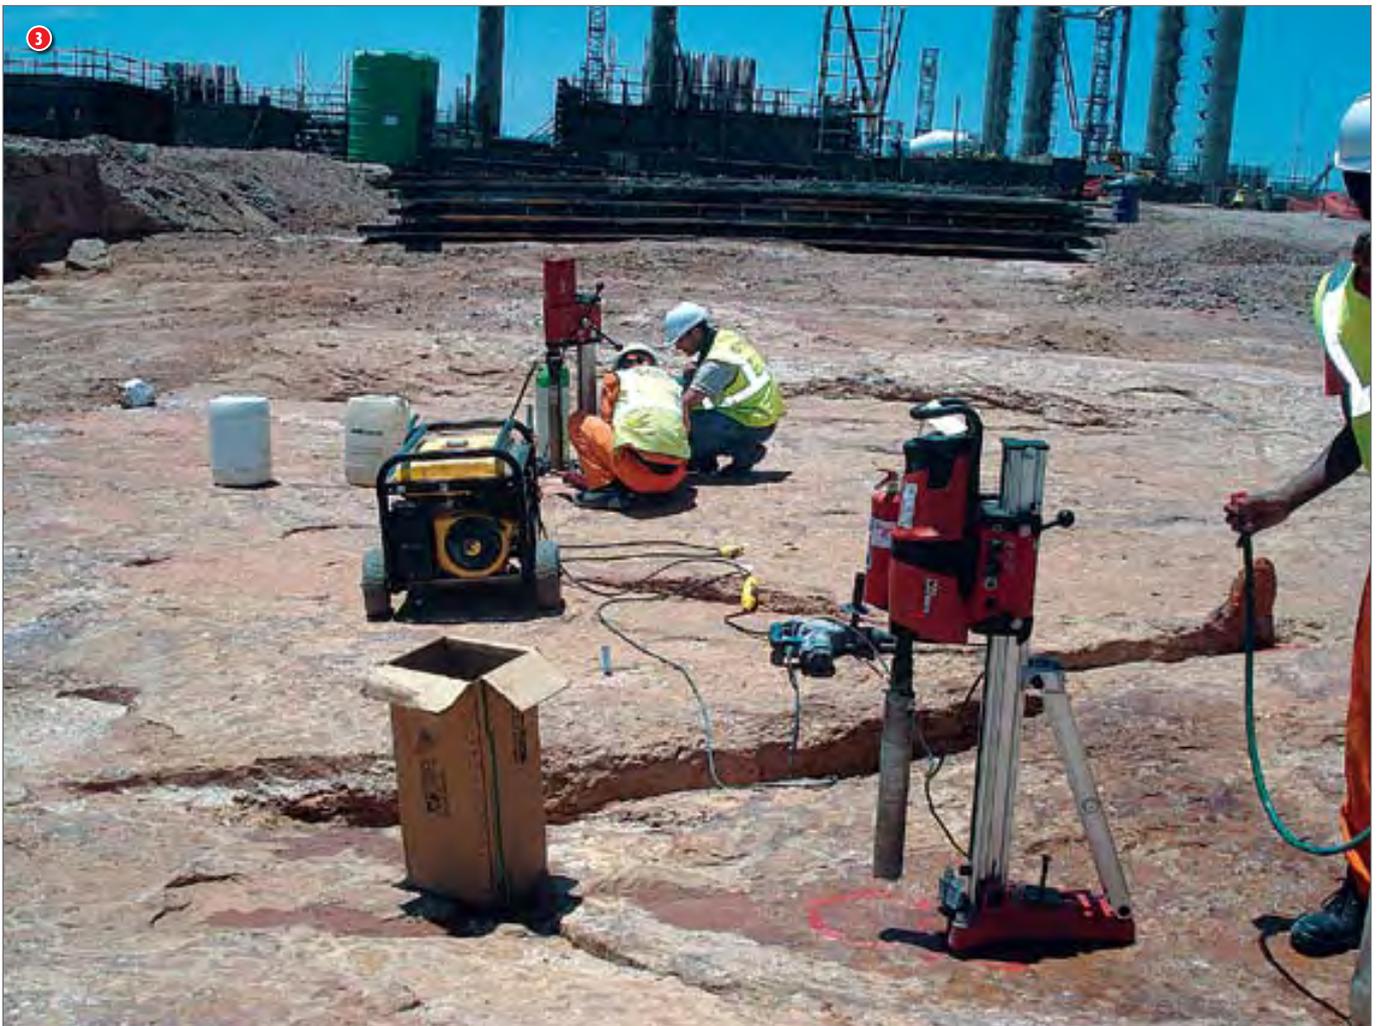
- 3 Rock cores being retrieved from foundation footprint using core drills
- 4 Example of a typical *Geotechnical Mapping of Foundations Record*
- 5 Hand sketch of foundation footprint

mapping. Measured orientations of the discontinuities are plotted on a stereo net (Figure 7) and rose diagram (Figure 8), depicting the orientation of major joints or fractures.

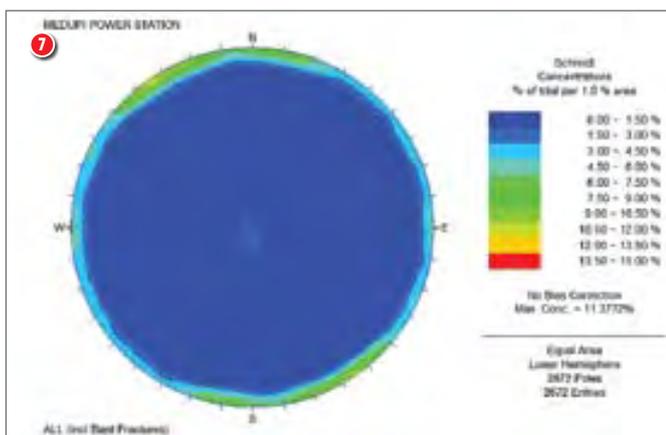
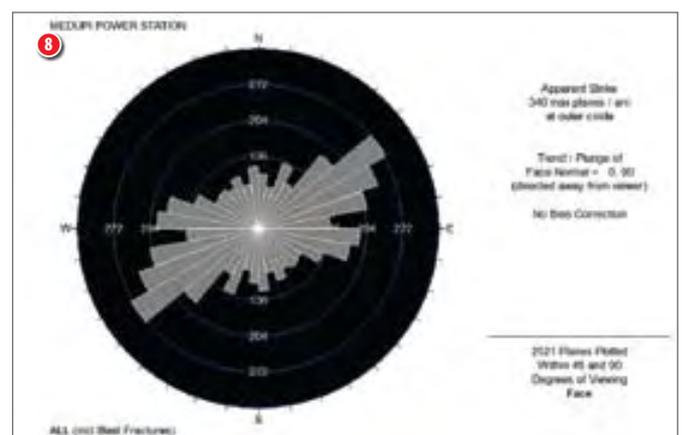
8 Rose net depicting strike directions of main joint or fracture orientations

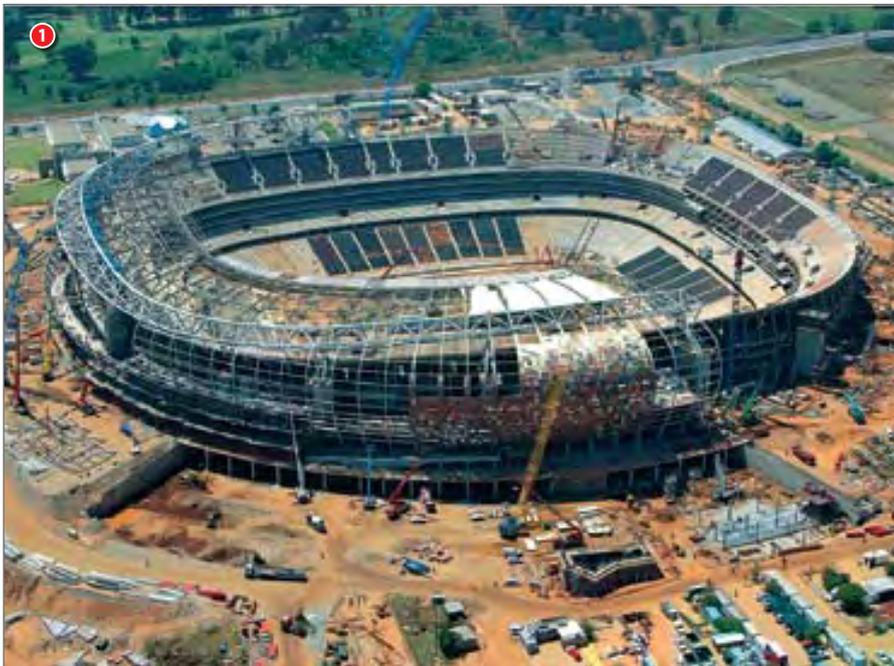
- 1 Aerial view of the Soccer City Stadium taken towards the end of 2008
- 2 Typical details showing tube-a-manchette grouting system at pile base

as usual and the grout is injected through the base of the pile at high pressure once the concrete shaft of the pile has reached sufficient strength. The density and compressive strength of any loose material at the base of the pile are significantly improved through this application and any voids are filled with grout.

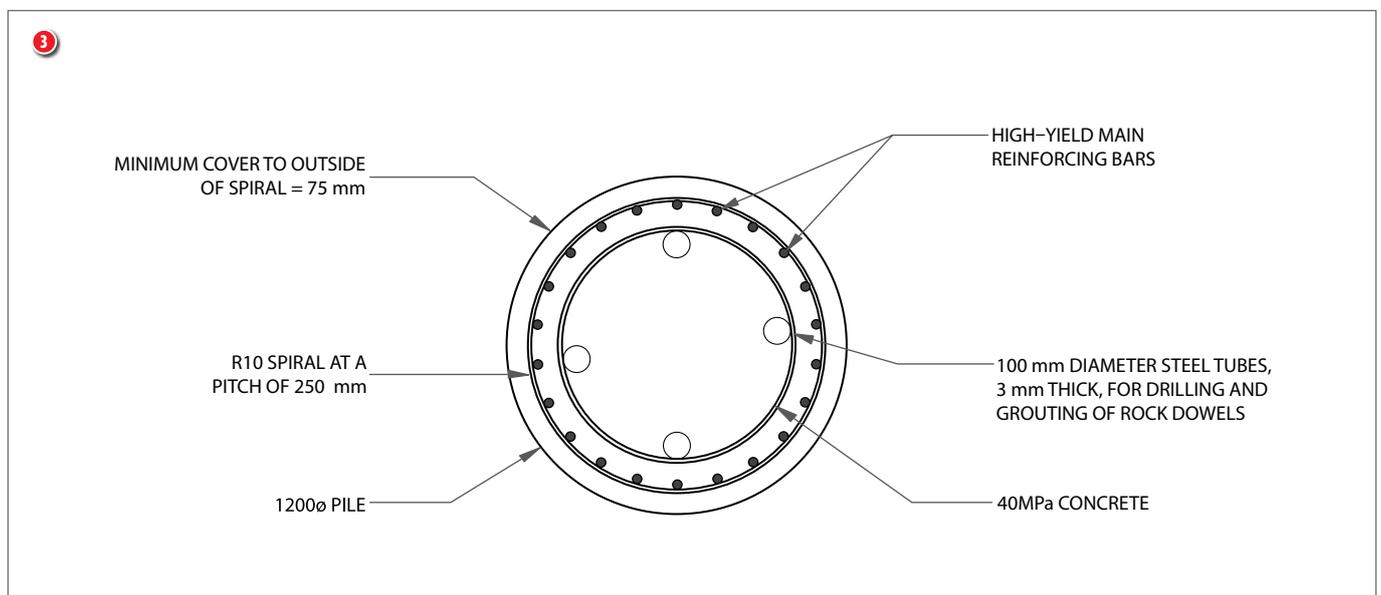
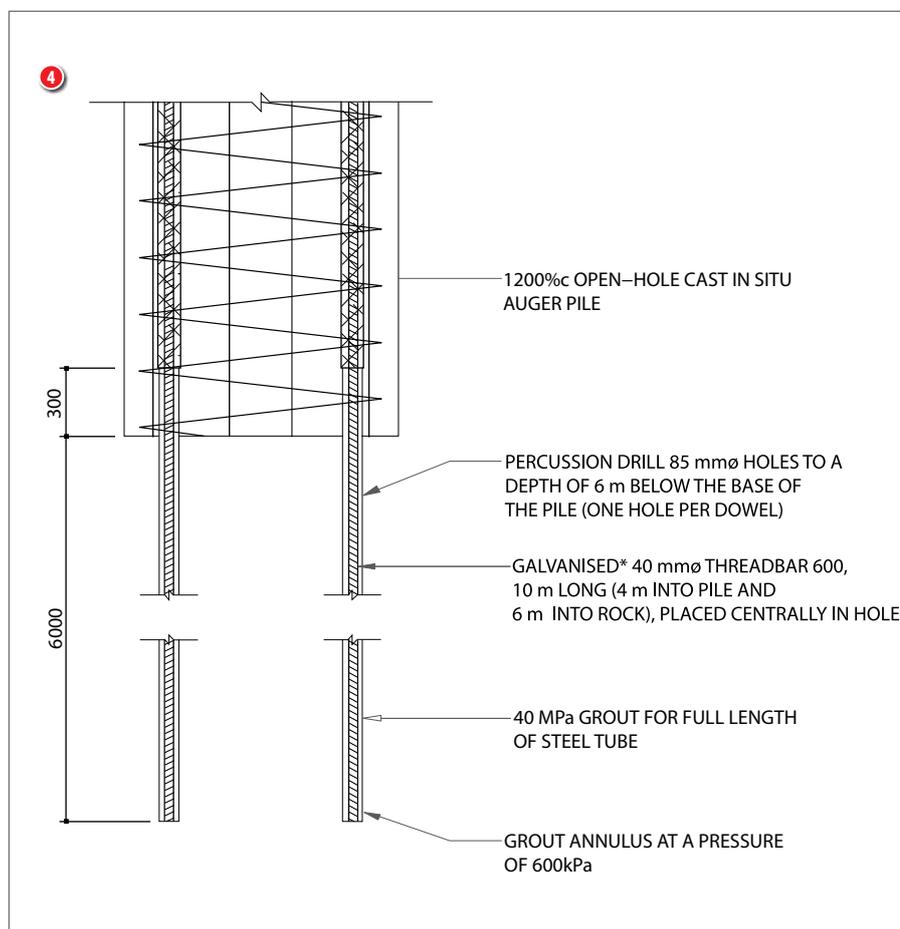
- 3 Typical section through a pile showing the steel tube arrangement
- 4 Typical detail showing dowel installation through the base of the pile

When the pile is being installed, a number of steel tubes, 100 mm in diameter, are placed in a circular arrangement into the augered hole, along with the steel reinforcing

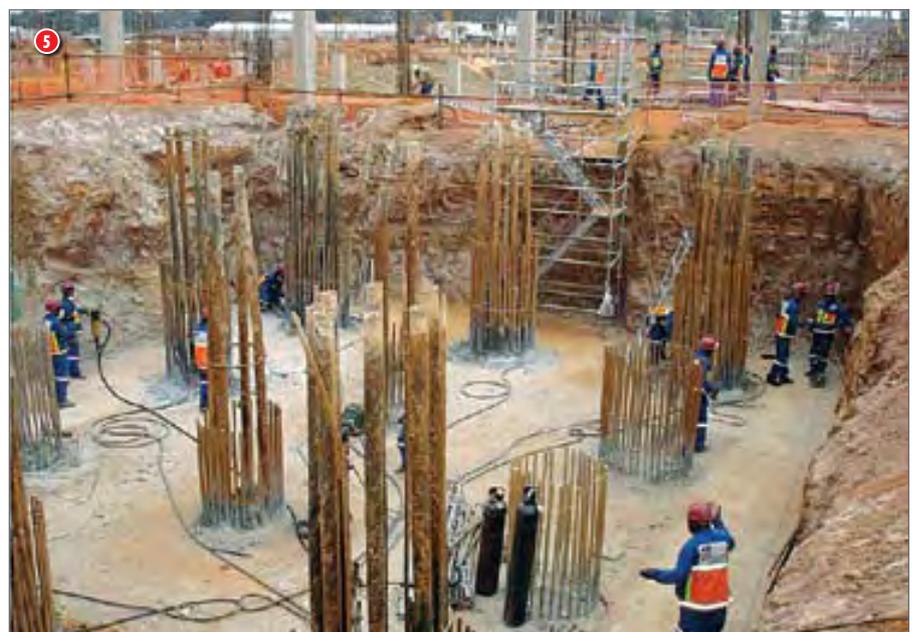
- 5 Preparation for one of the pile caps of the 12 shafts
- 6 & 7 Steel tubes and pile reinforcing on one of the shaft piles

Unfortunately, the rock strength and depth across the site is highly variable, and therefore only limited capacity can be safely generated in the rock socket. In order to accommodate these massive loads, it was decided to anchor the piles into the sandstone bedrock using dowel bars installed through the base of the pile. Between four and eight 100 mm steel tubes were cast into the pile to a depth of 300 mm above the pile/rock interface (see Figures 5, 6 and 7).

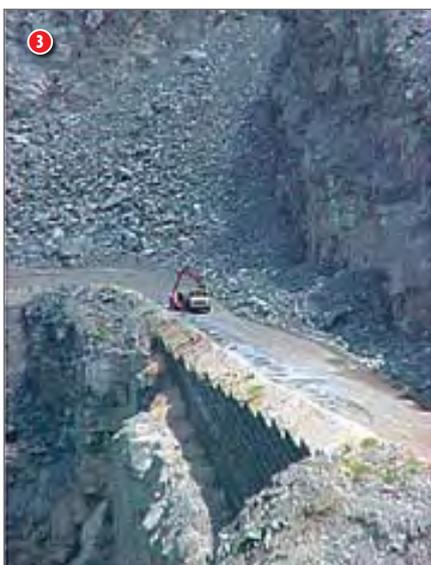
Maccaferri SA (or African Gabions as it was then known) produced a design in January 2005 for a vertical tip wall to enable access to a 20-m-high loading bin at the primary crusher at Marikana platinum mine (Figures 4 & 5). The Terramesh™ System was proposed for the main and wing walls. The wall was

The first year's results showed that the wall had settled by at least 160 mm from its initial horizontal position. In addition to this, as expected, the face of the wall had rotated in the vertical plane to the extent that the wall had moved at least 40 mm away from the crusher. In other words, this rotation measured 0,12° backwards. The final results at the end of the five-year period showed that the progressive total settlement had reached an average of 221 mm, with a rotation of 80 mm or 0,19°. The graph in Figure 6 illustrates this trend and also shows how the rate of consolidation of the underlying soil formation is "flattening out".

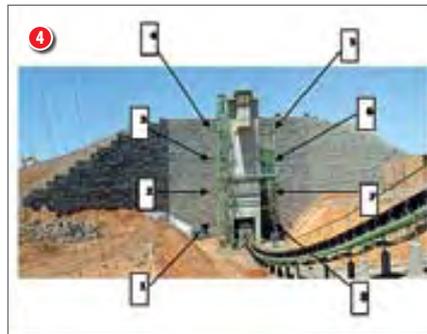
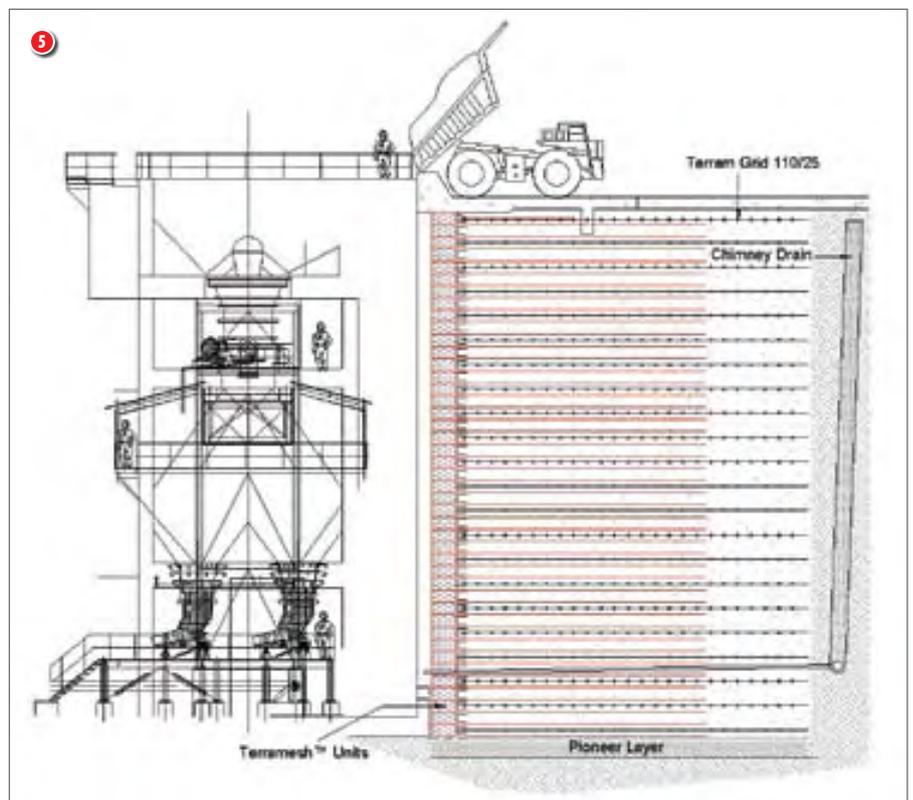
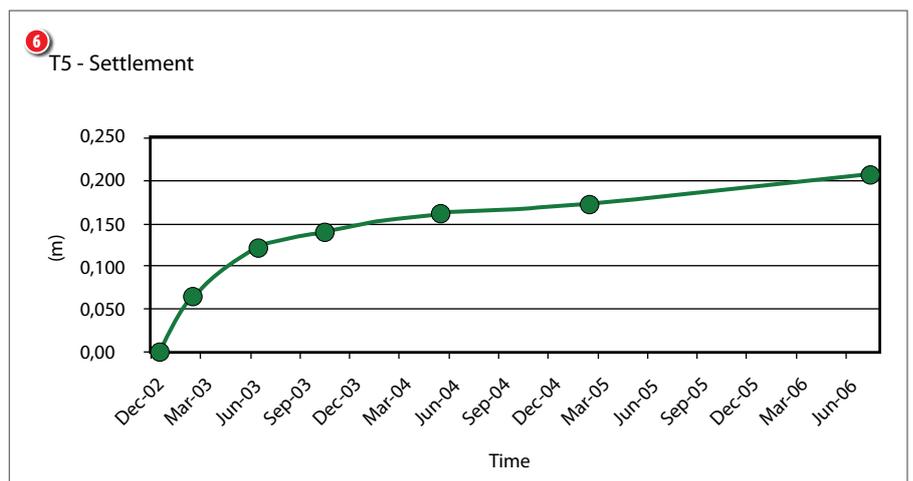
7

- 2 Cross-section through the 15-m-high Terramesh™ retaining wall
- 3 View of the Terramesh™ System ramp during construction
- 4 Front elevation of the tip wall
- 5 Cross-section through the Terramesh™ System tip wall
- 6 Graphical representation of settlement of the wall over five years

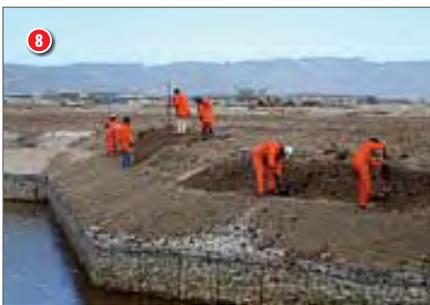
- 7 Layout of Thesen Island Marina
- 8 Preparing for vegetation
- 9 Vegetated slope
- 10 Measurement of corrosion penetration
- 11 Sample under test

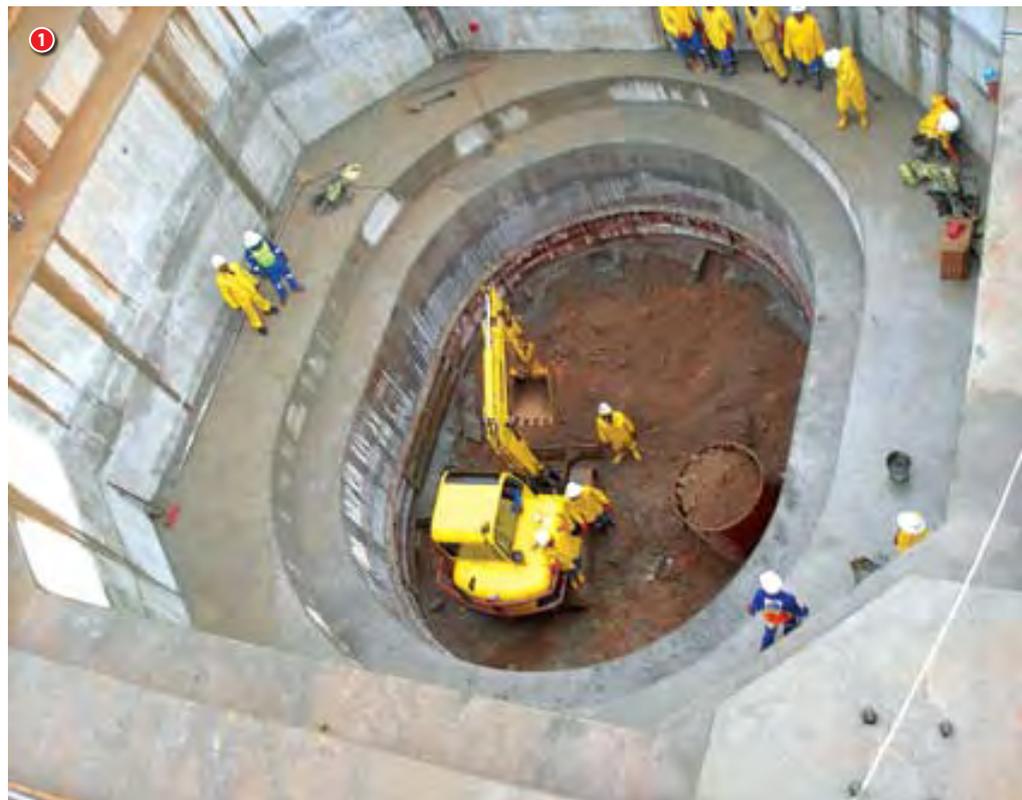
3 View of the shaft and stage during the construction of the lower ring beam

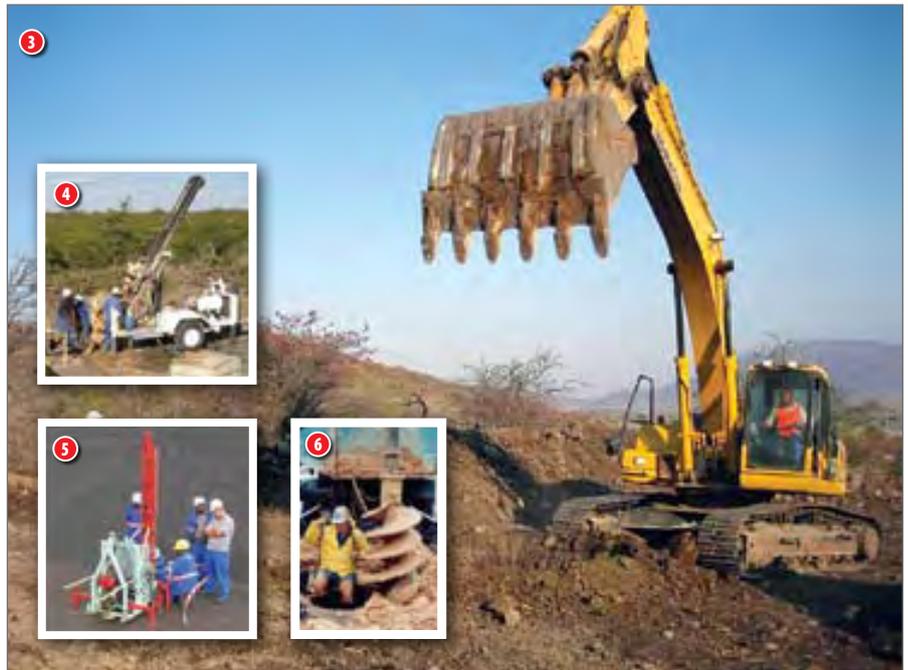
(dynamic penetration super heavy) testing. Although it is invasive in that it means physical penetration of the probe into the soil, DPSH testing does not require much surface space (Figure 5) and is relatively quick and cost-effective. However, these non-invasive techniques do have their limitations: they provide only a general indication of depth to bedrock and structural setting. Selected invasive methods may have to be used to assist in acquiring the basic information needed to conclude the preliminary phase of the investigation.

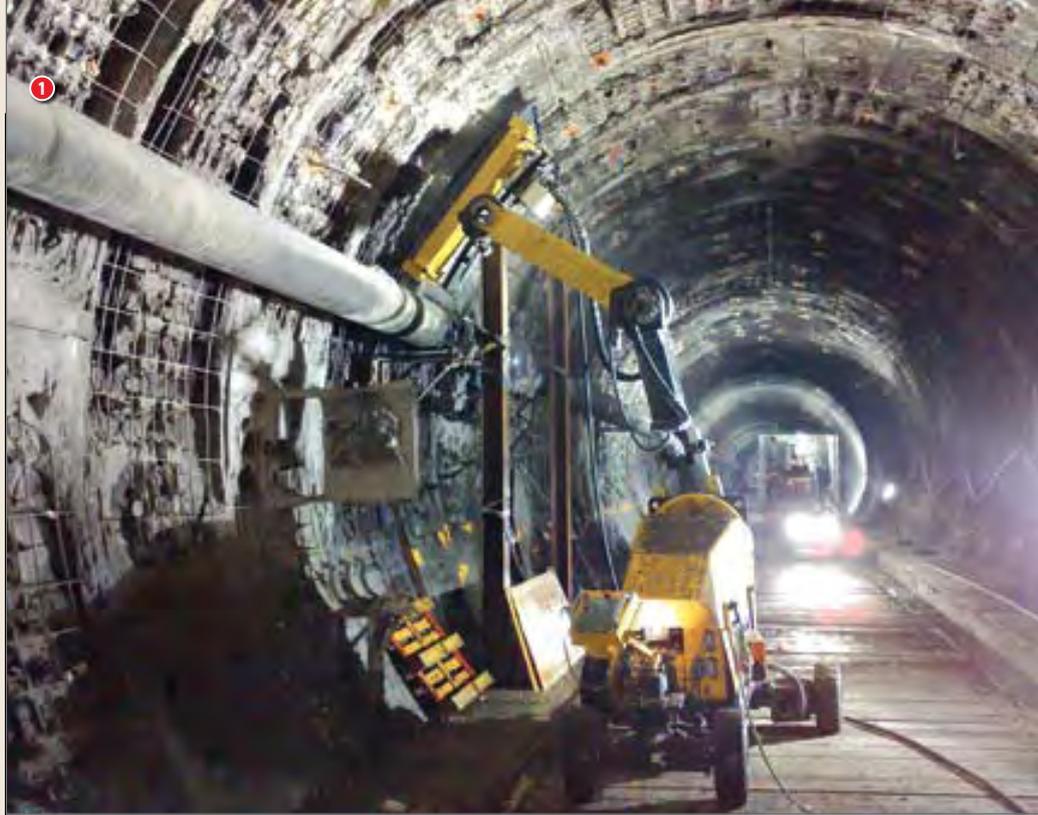
1 The total area of removal of the fire-damaged concrete with the Conjet hydrodemolition robots was about 9 500 m² over approximately 600 m of tunnel, including about 350 m² directly above the fire where the damage was most severe

TRAIN SERVICES THROUGH the Channel Tunnel linking Britain and France were scheduled to be fully restored in February 2009 following several months of repairs after a major fire in the tunnel on 11 September 2008. A lorry caught fire on a Shuttle train carrying heavy goods vehicles bound for France through the 50-km-long northern tunnel. The fire, which spread to other vehicles, raged for about 16 hours. The extreme temperatures of up to 1 000°C caused extensive damage to about 600 m of the 7,6-m-diameter tunnel's concrete lining, approximately 11 km in from the French entrance.
