Civil Engineering

April 2009 Vol 17 No 3

FOCUS ON GEOTECHNICAL ENGINEERING

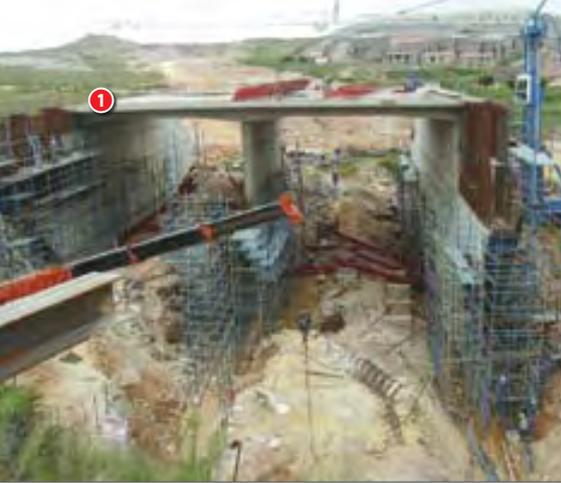
① Four-lane bridge in preparation for jacking under rail embankment

A further key feature is the new four-lane underpass bridge under the main Soweto

rail line. This structure will be the largest pre-constructed structure in South Africa and will be jacked into place through the rail embankment.

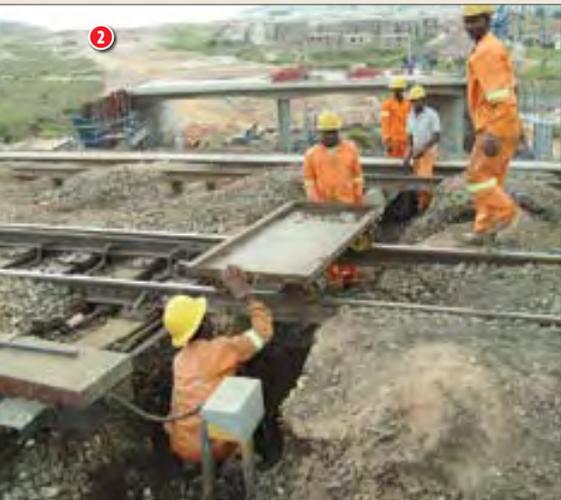
② Rail strapping in preparation for bridge jacking

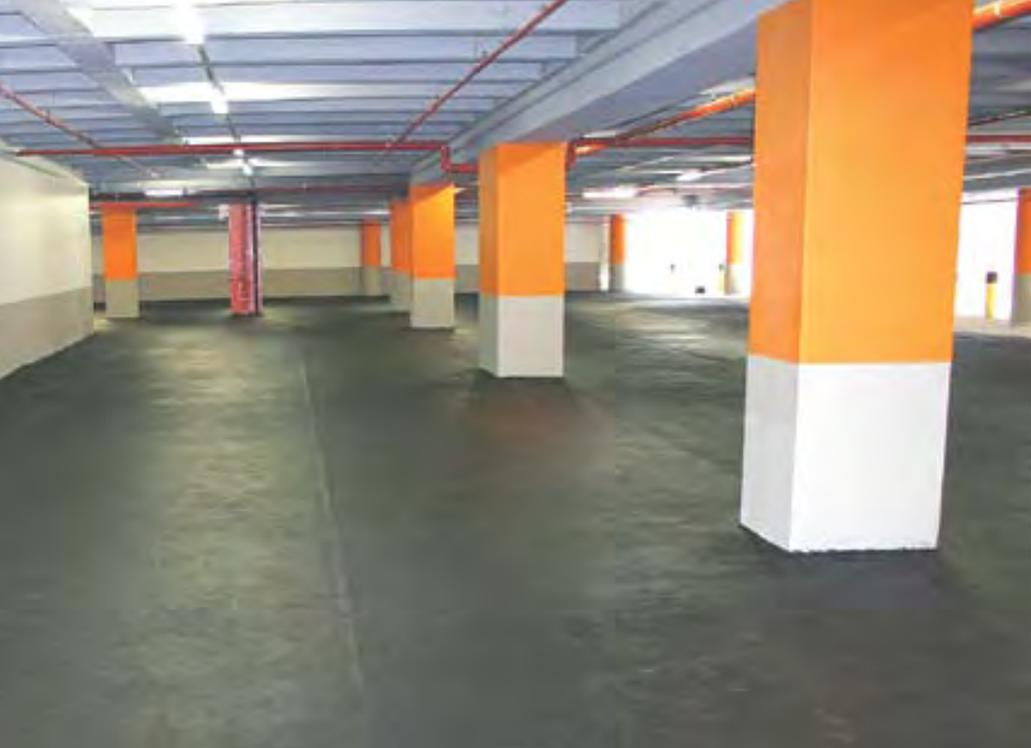
① a.b.e. Construction Chemicals' specialist flooring product, abeco mastic, was used for the flooring of the basement parking area at ABSA Capital in Sandton

abeco mastic is a cold-laid bituminous mastic consisting of stone chippings, portland cement, sand and flintkote 3 binder. The flooring system – which does not require any expansion or contraction joints – has a service history of around 50 years on the local market and is suitable for areas such as warehouses, railway platforms, printing works, heavily trafficked corridors,

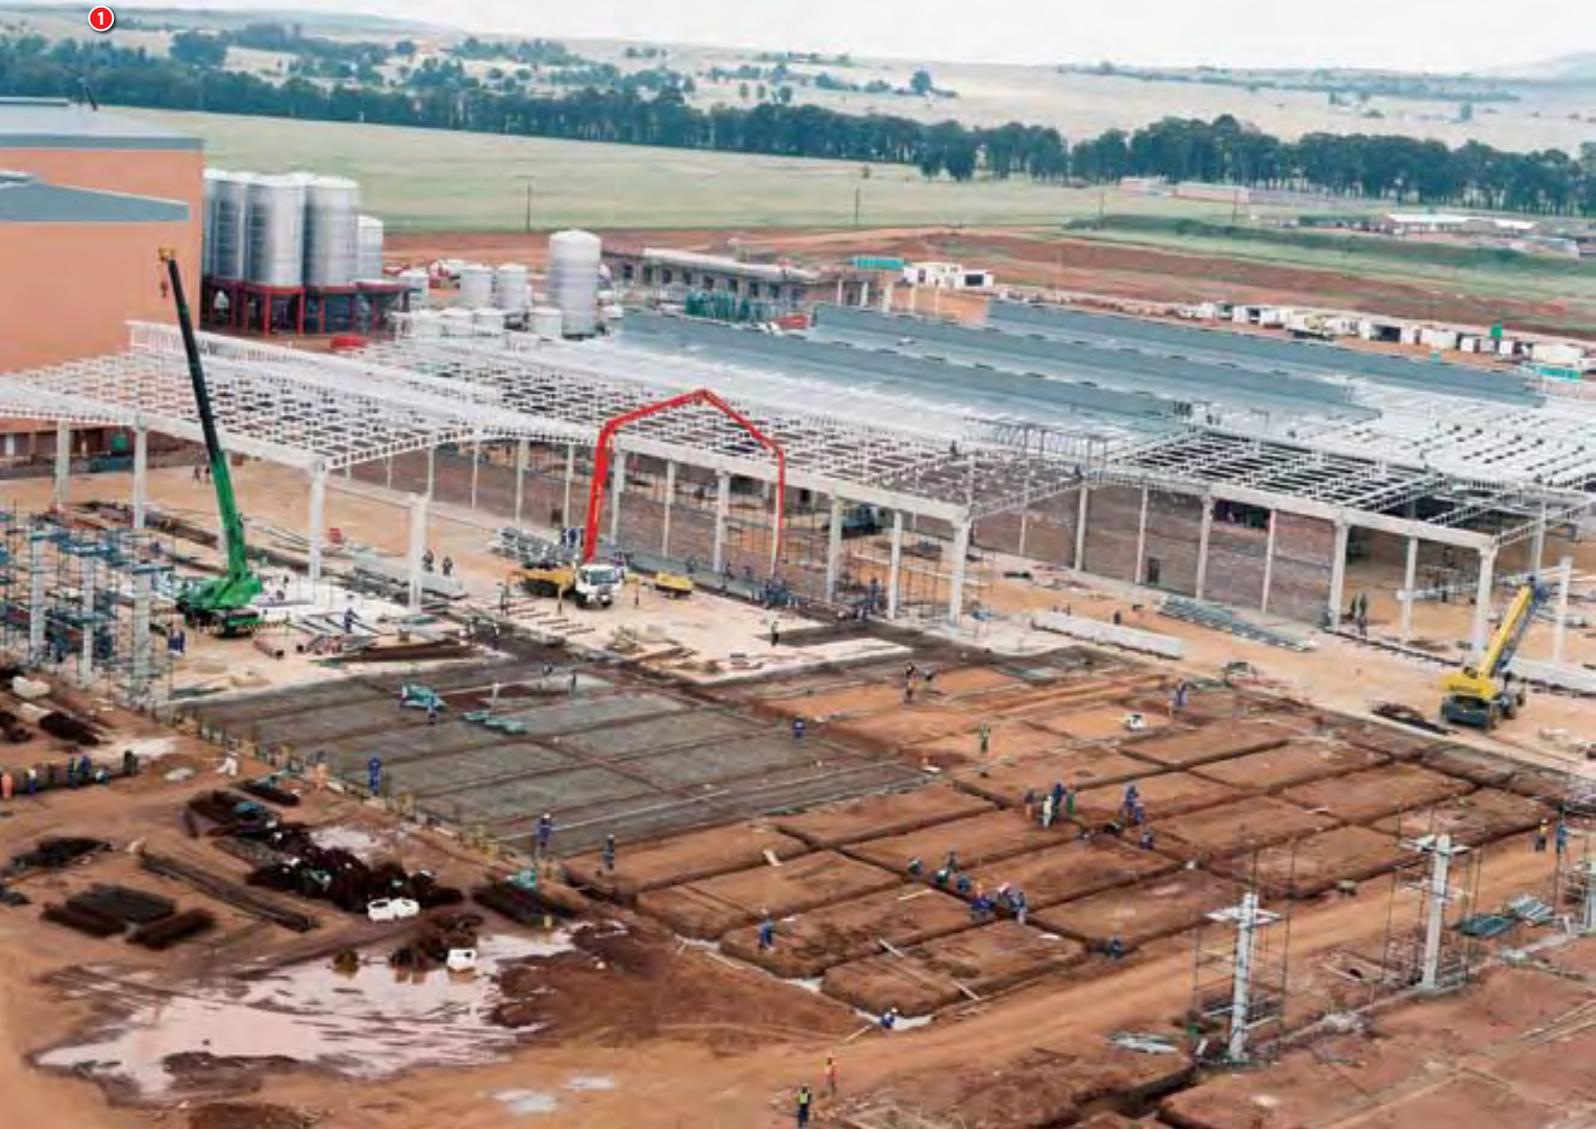
1 Aerial view of the new Heineken Brewery at Kliprivier showing the sophisticated slab construction in the bottling area

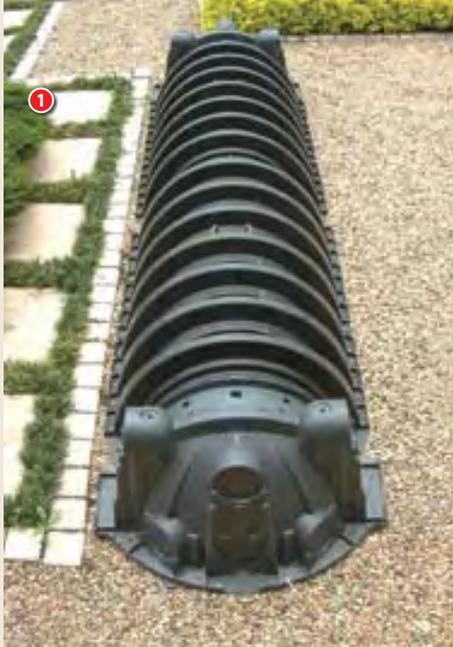
1 The Chamber fitted with a Multi-Port End Cap

The new soak pit was formed by joining 14 Quick4 Infiltrator Chambers end-to-end. The design of the new Chamber System permits a 10 degree swivel at each join, allowing the construction to follow the contour of the
